**TRANSPORTATION RESEARCH CENTER**

**ON-SITE AIR BAG INVESTIGATION**

CASE NO. - 90-01  
FLEET - PRIVATE VEHICLE  
LOCATION - [REDACTED] INDIANA  
ACCIDENT DATE - [REDACTED] 1990

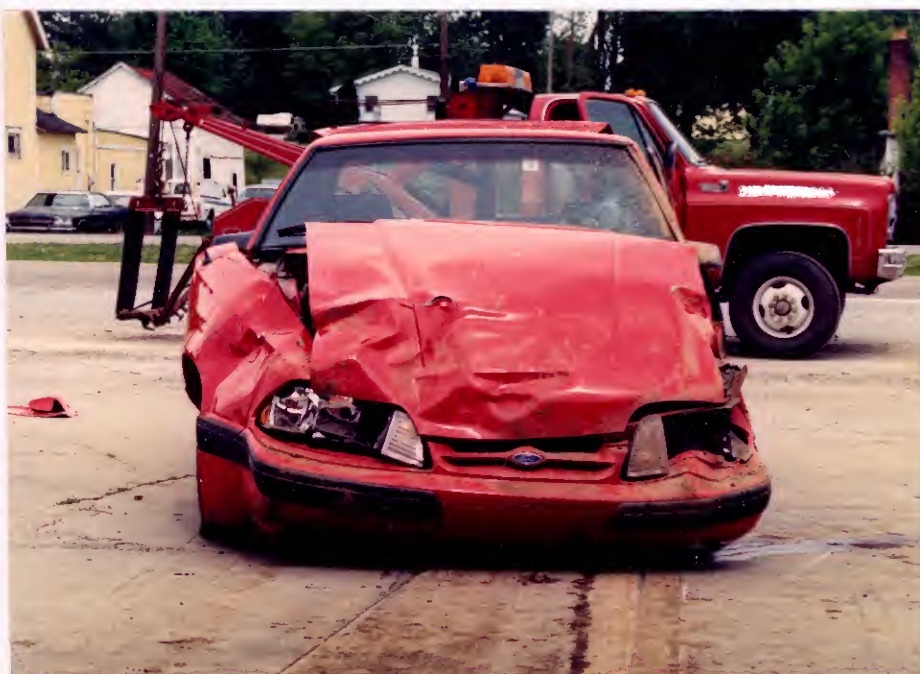
# 01 -- 1990  
Indiana  
TRC/IU: 90-01, Task: 0068  
Mustang frontal view

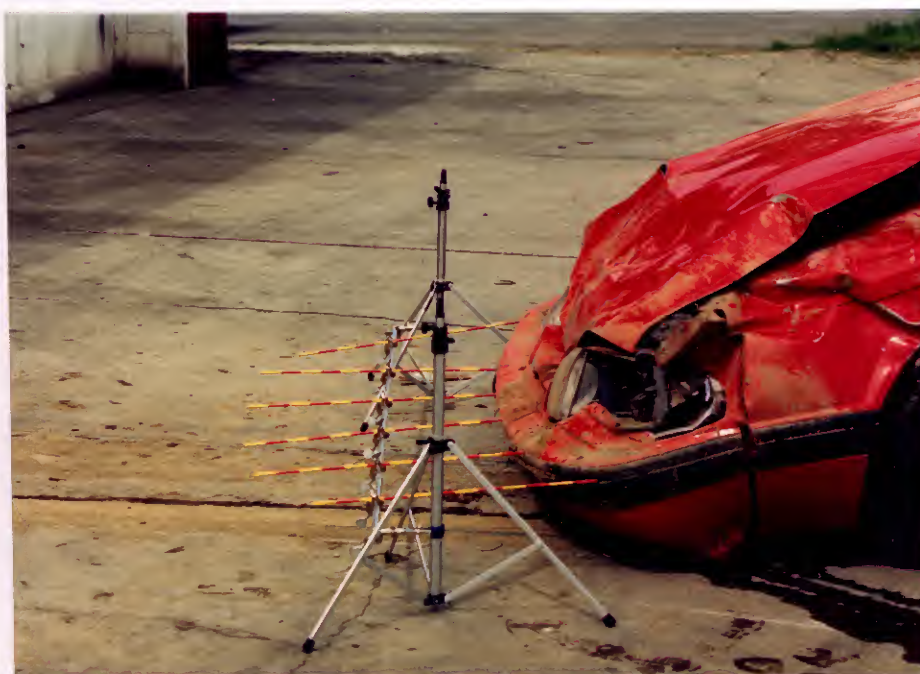
# 02 -- 1990  
Indiana  
TRC/IU: 90-01, Task: 0068  
Across front from left side

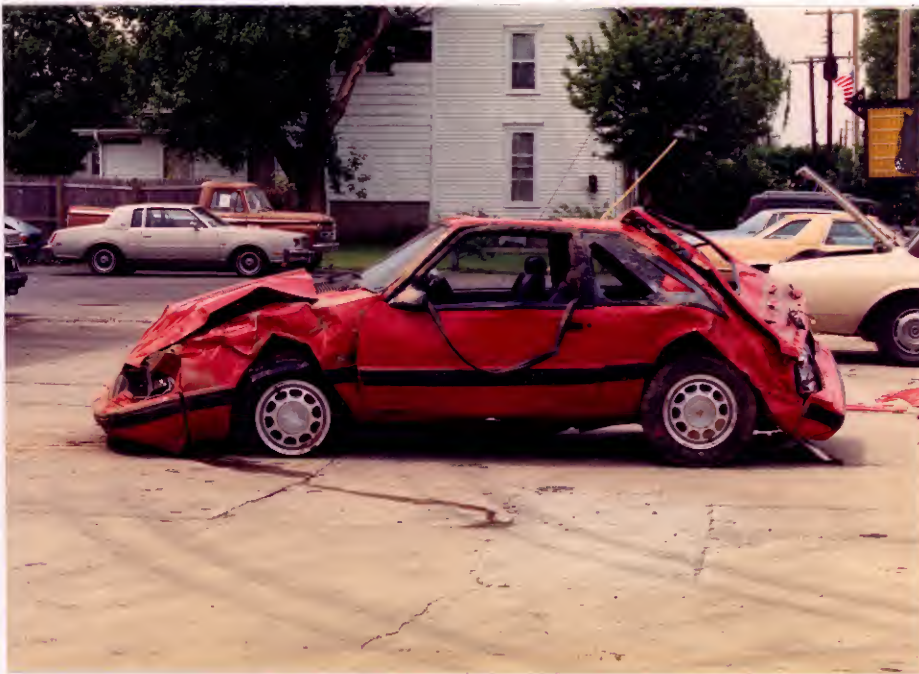
# 03 - 1990  
Indiana  
TRC/IU: 90-01, Task: 0068  
Full left side view

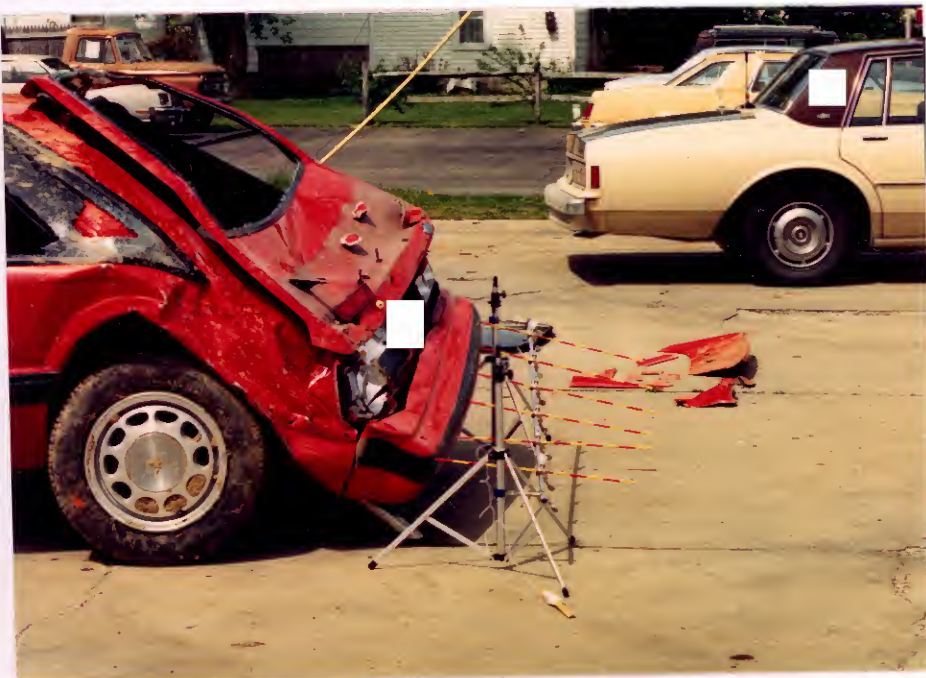
# 04 - 1990  
Indiana  
TRC/IU: 90-01, Task: 0068  
Across rear from left side

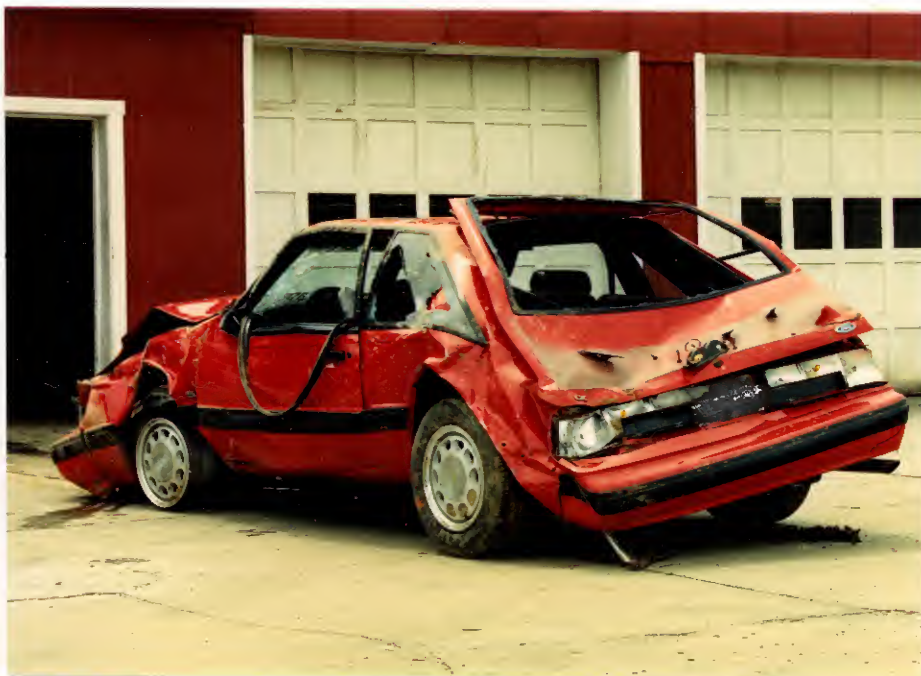
# 05 -- 1990  
Indiana  
TRC/IU: 90-01, Task: 0068  
Left rear rearside view

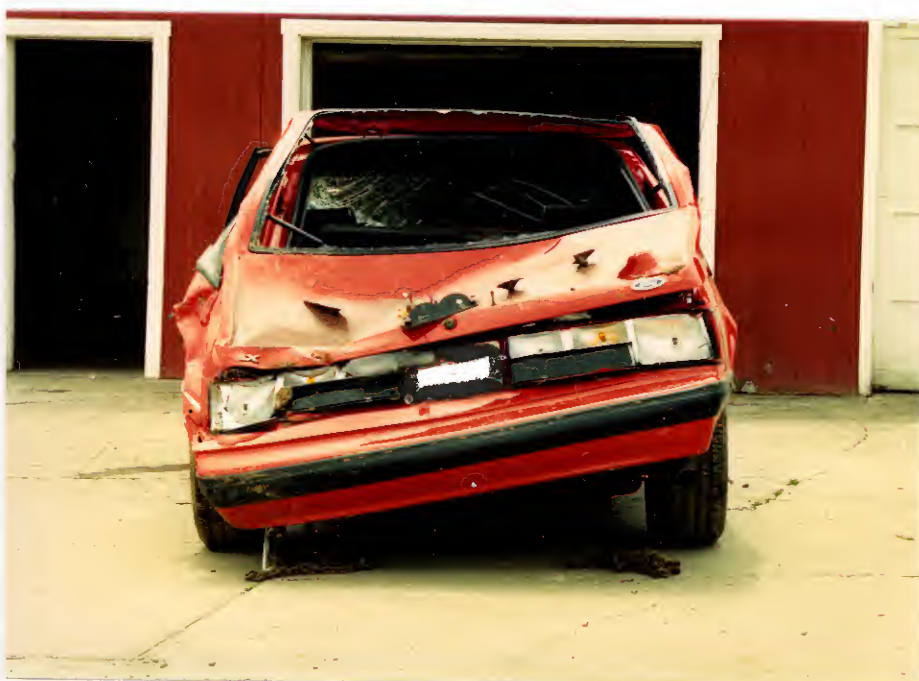
# 06 -- , 1990  
Indiana  
TRC/IU: 90-01, Task: 0068  
Damaged rear plane

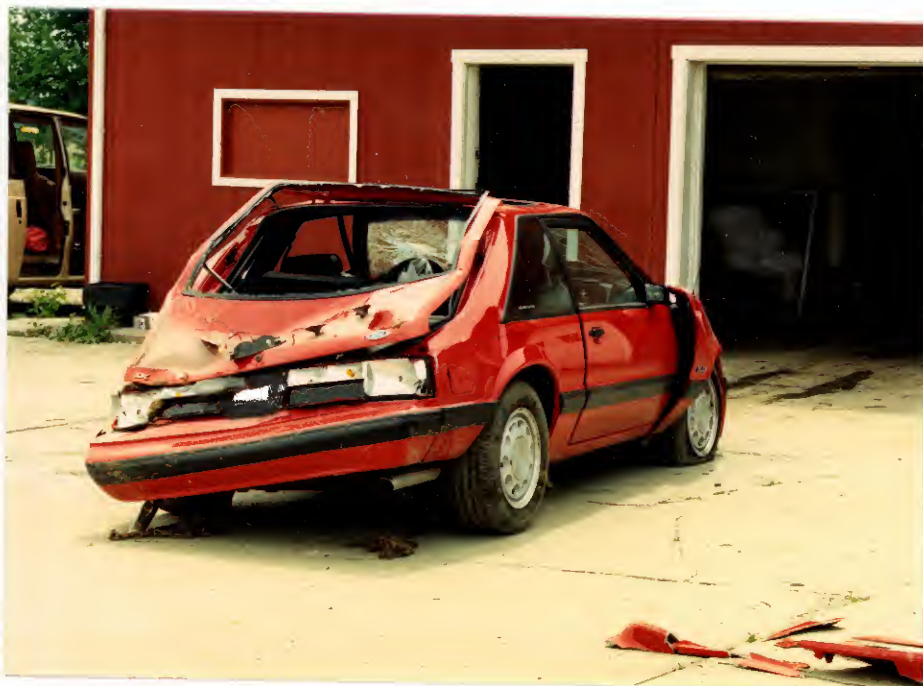
# 07 , 1990  
Indiana  
TRC/IU: 90-01, Task: 0068  
Right rear rearside view

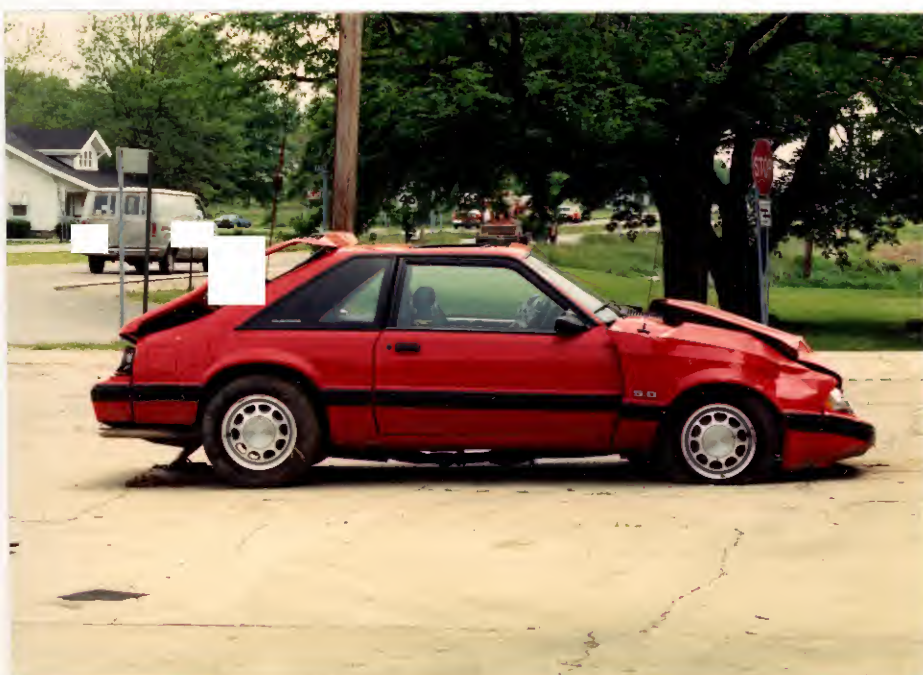
# 08 - 1990  
Indiana  
TRC/IU: 90-01, Task: 0068  
Full right side view

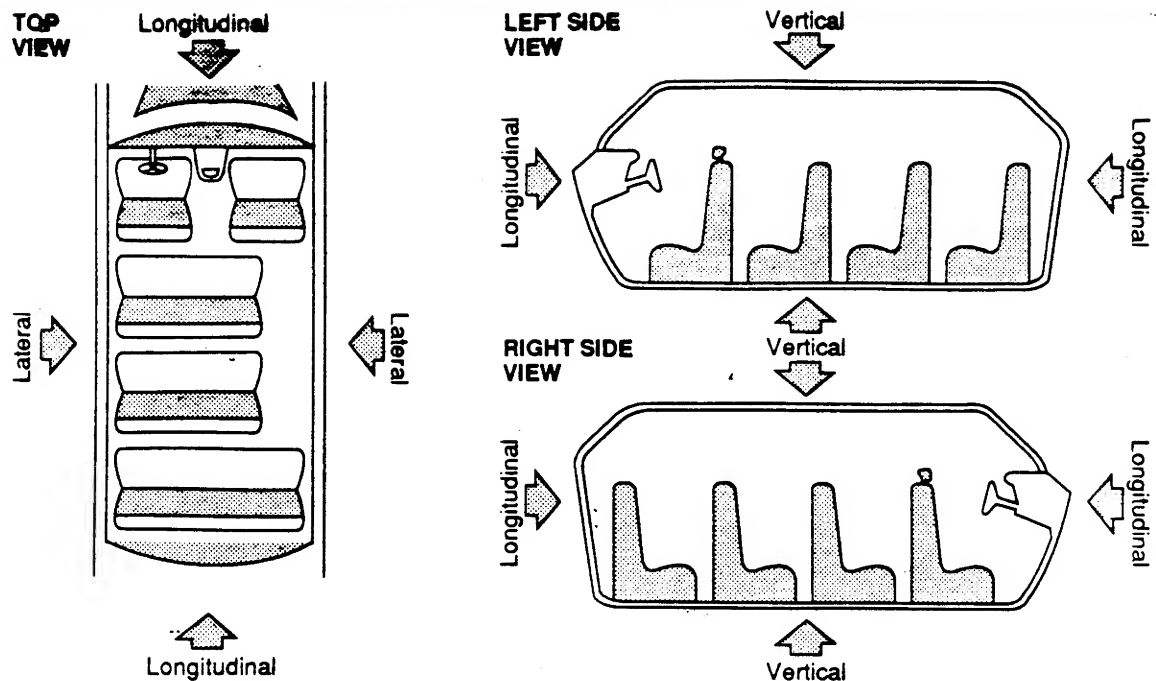
## INTRUSION WORK SHEET

LOCATION OF INTRUSION	INTRUDED COMPONENT	COMPARISON VALUE	-	INTRUDED VALUE	=	INTRUSION	DOMINANT CRUSH DIRECTION
1-1	TOE PAN	20.75	-	16.5	=	4.25	LONG
1-1	LOWER A-PILLAR	19.25	-	16.5	=	2.75	LAT
1-1	FLOOR PAN	23.5	-	22.5	=	1.0	VERT
1-1	LF DOOR SILL - FORWARD	19.25	-	19.0	=	0.25	LAT
1-1	LF DOOR SILL - MID	34.75	-	35.0	=	-0.25	VERT
1-1	LF DOOR SILL - REAR	28.0	-	30.0	=	-2.0	VERT
2-1	LOWER B PILLAR	25.5	-	29.5	=	-4.0	VERT
2-1	UPPER C PILLAR	25.0	-	30.0	=	-5.0	VERT
2-1	FLOOR PAN	43.0	-	41.75	=	1.25	VERT
2-2	FLOOR PAN	46.0	-	41.75	=	4.25	VERT
			-		=		
			-		=		
			-		=		
			-		=		
			-		=
